## Case Study: Improvement of the Maer Lane STW Inlet Works

HUBER Technology recently completed and commissioned a large project for South West Water to improve the inlet works facility at the above site which treats the sewage from the town of Exmouth in Devon.

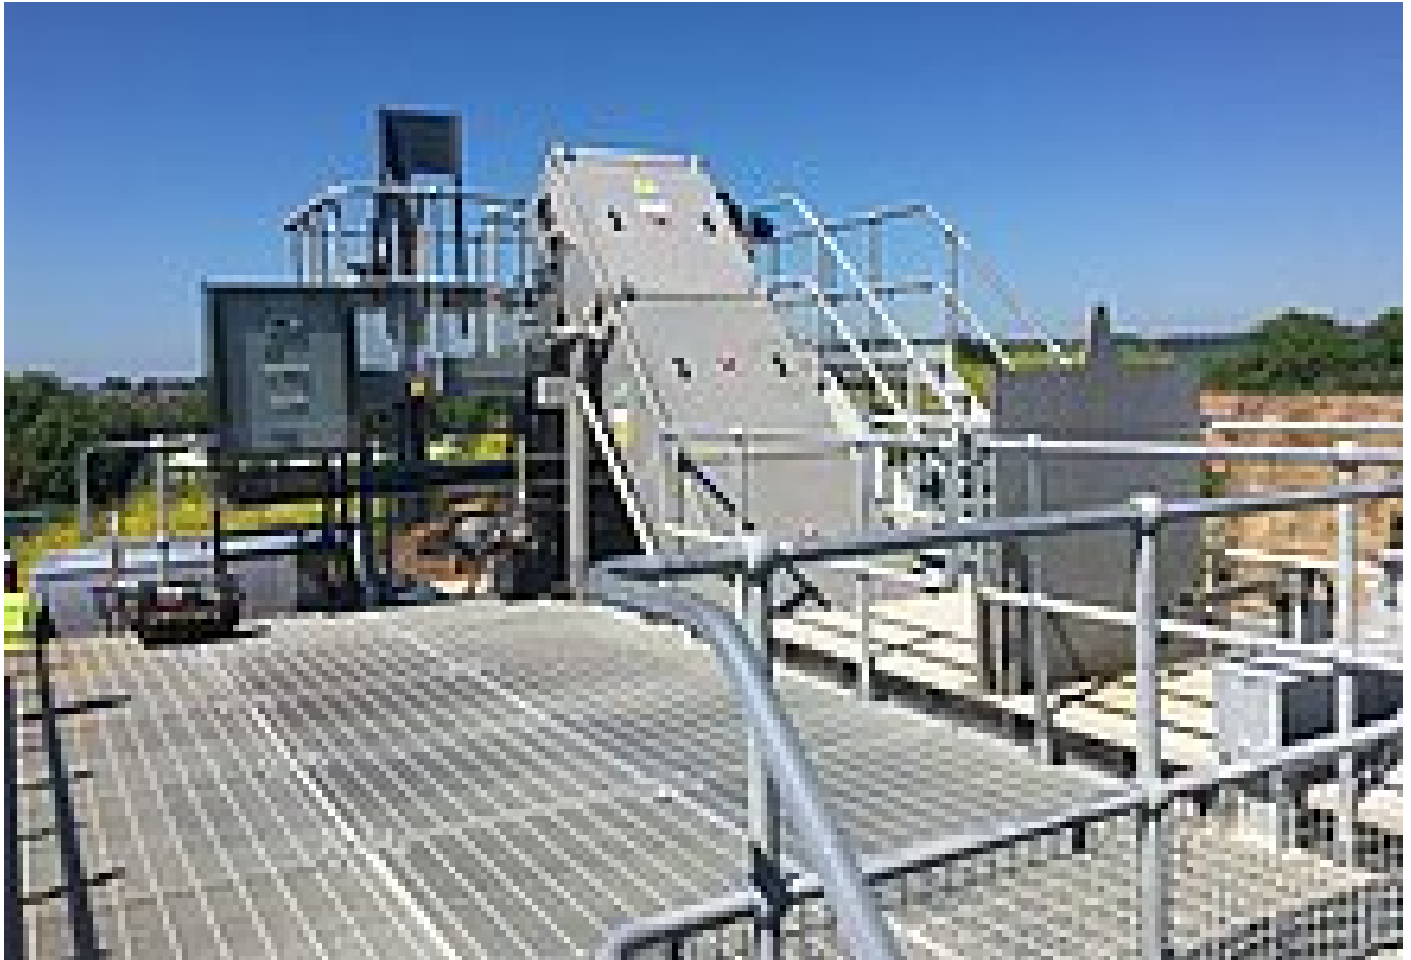
*New RakeMax® screen installed on top of the existing balance tank*

Previously the flow into the balance tank was via four pumped rising mains, flow to the inlet screens was controlled by penstocks in the balance tank. We worked with the contractors – Tecker to develop a solution to minimise downtime. This solution was to install the coarse screen into a off-site fabricated site channel which could be mounted on top of the existing balance tank structure.

This was installed on site and the rising main connections made, the coarse screen was then installed into it with the screening discharging directly to a skip.

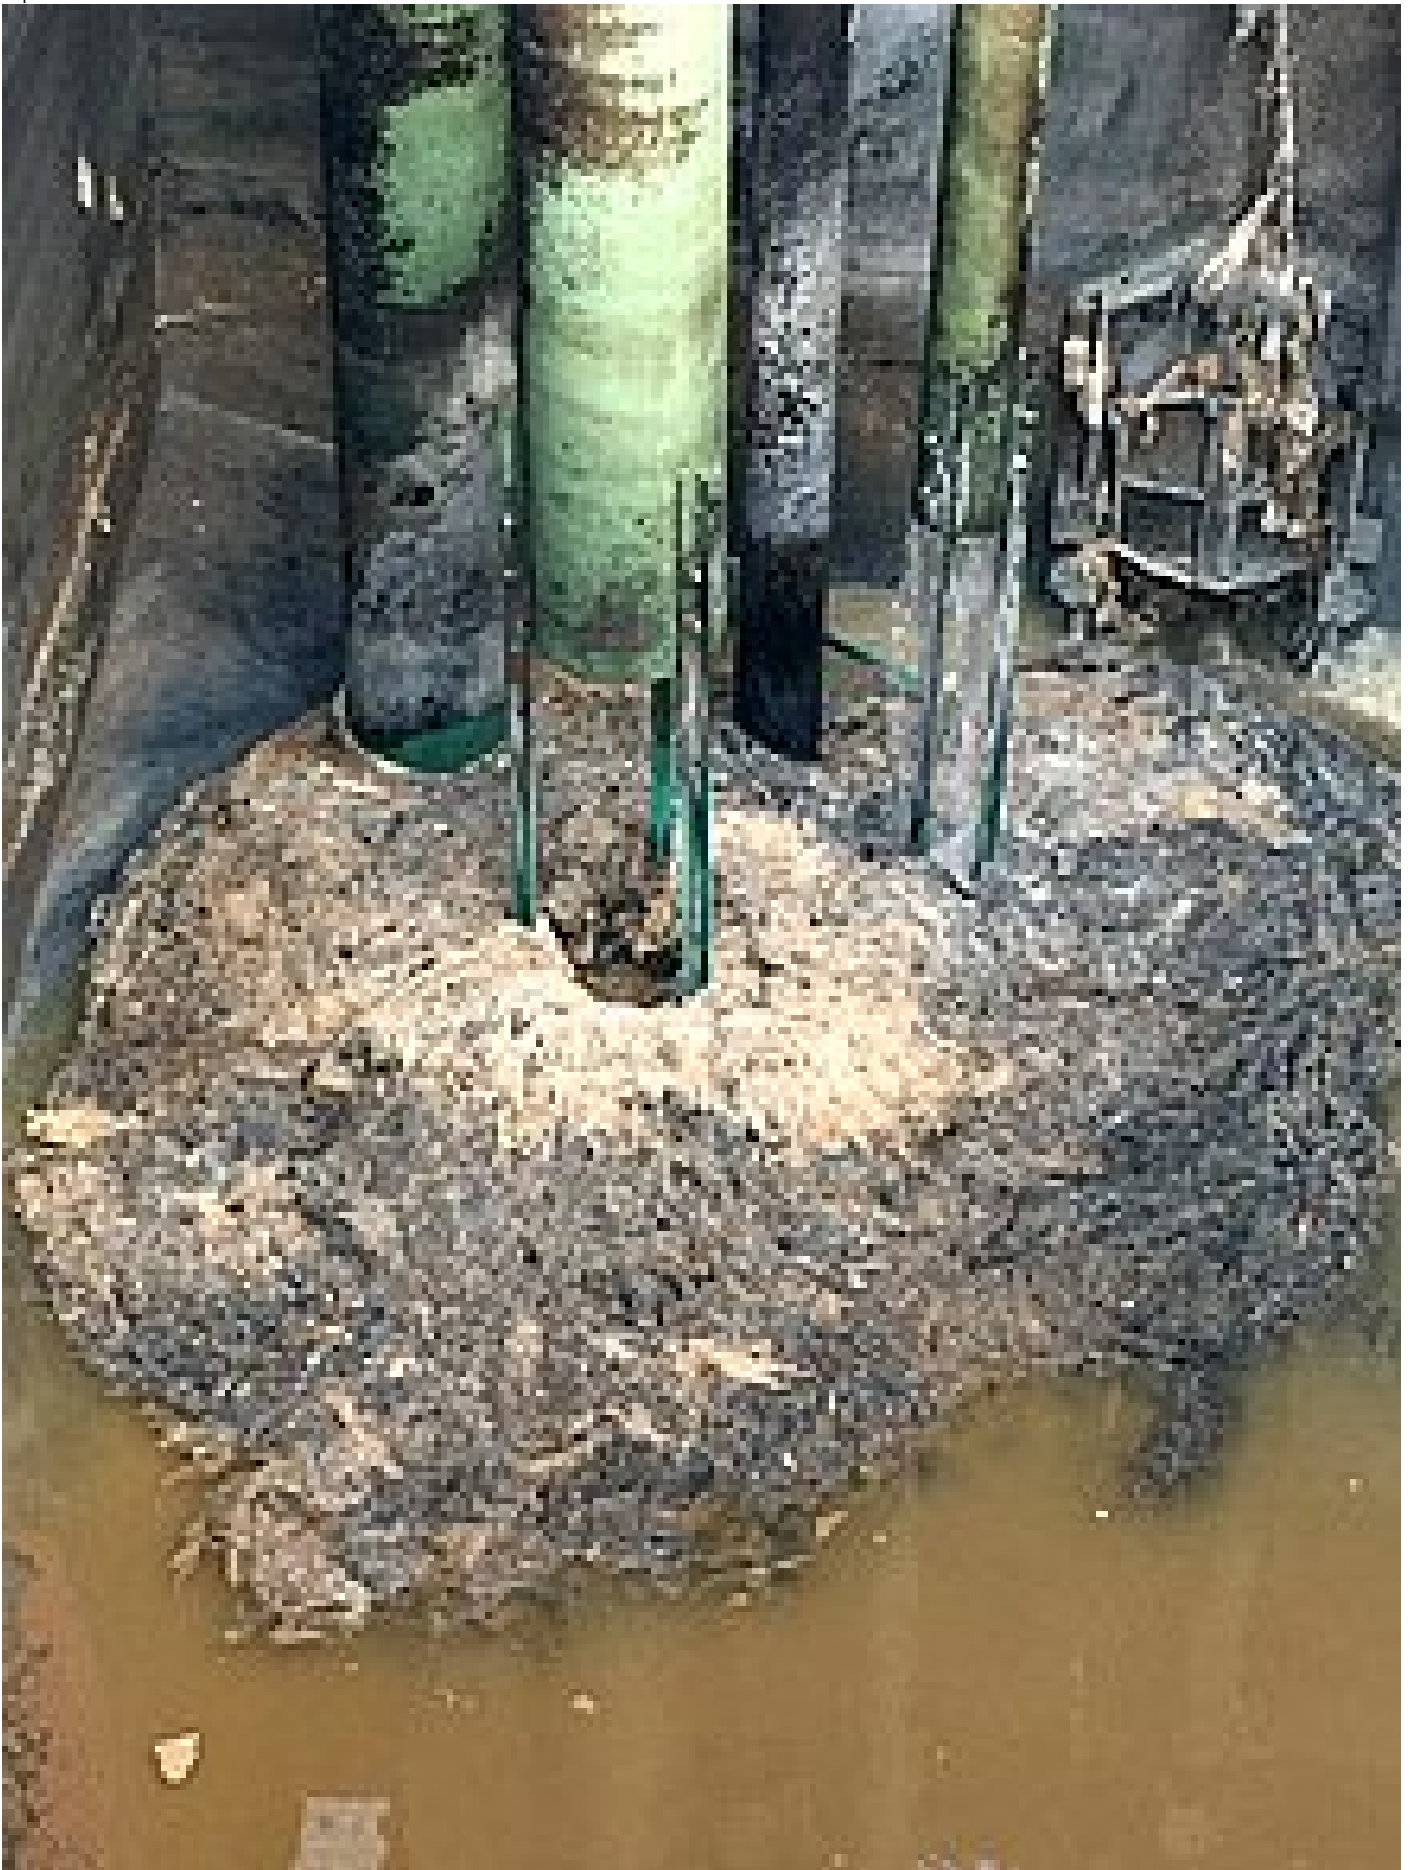
*Screenings build up in balance tank – before screens were fitted*

HUBER Technology were approached by Tecker towards the end of 2015 to look at improving the existing inlet works on site. The site features a balance tank which was prone to a large build up of rag and screening which were overloading the existing inlet works. Cleaning of this rag build up proved difficult and dangerous so the project was split into two sections, supply of a coarse screen to protect the balance and storm tanks and supply of new fine inlet screens and screenings handling equipment.
