## Charfield STW Case Study: Inlet Screen Replacement Project

**As part of the Wessex Water inlet screen replacement projects, HUBER Technology completed the delivery and installation of a new inlet screen and screenings handling project at Charfield STW near Wootton under Edge.**

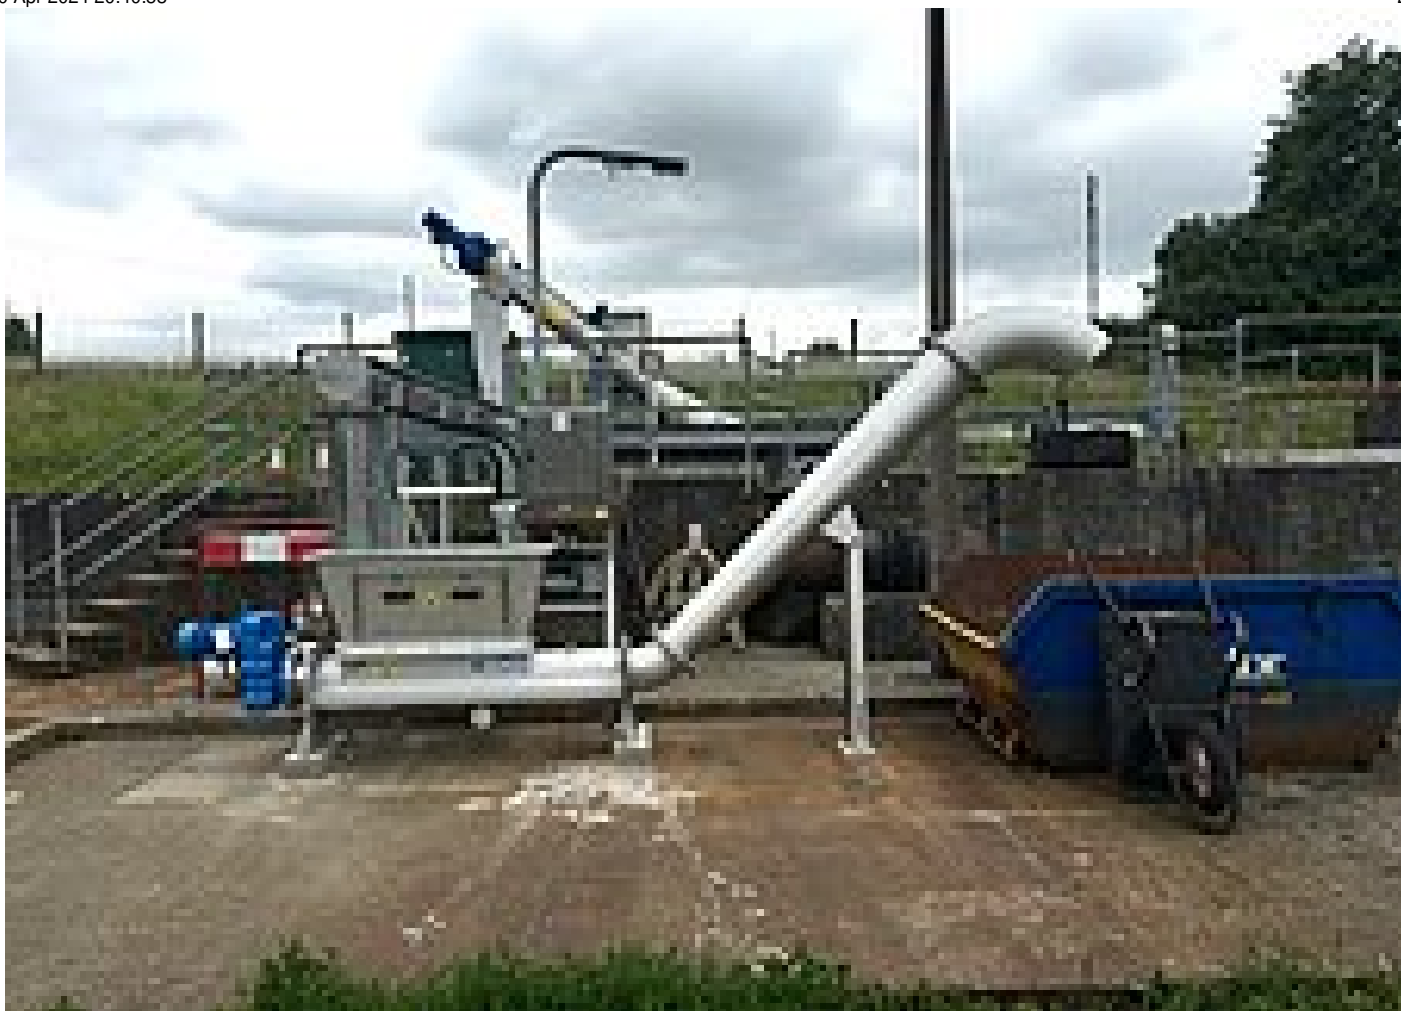
*The complete HUBER installation with Wash Press WAP®/L in the foreground*

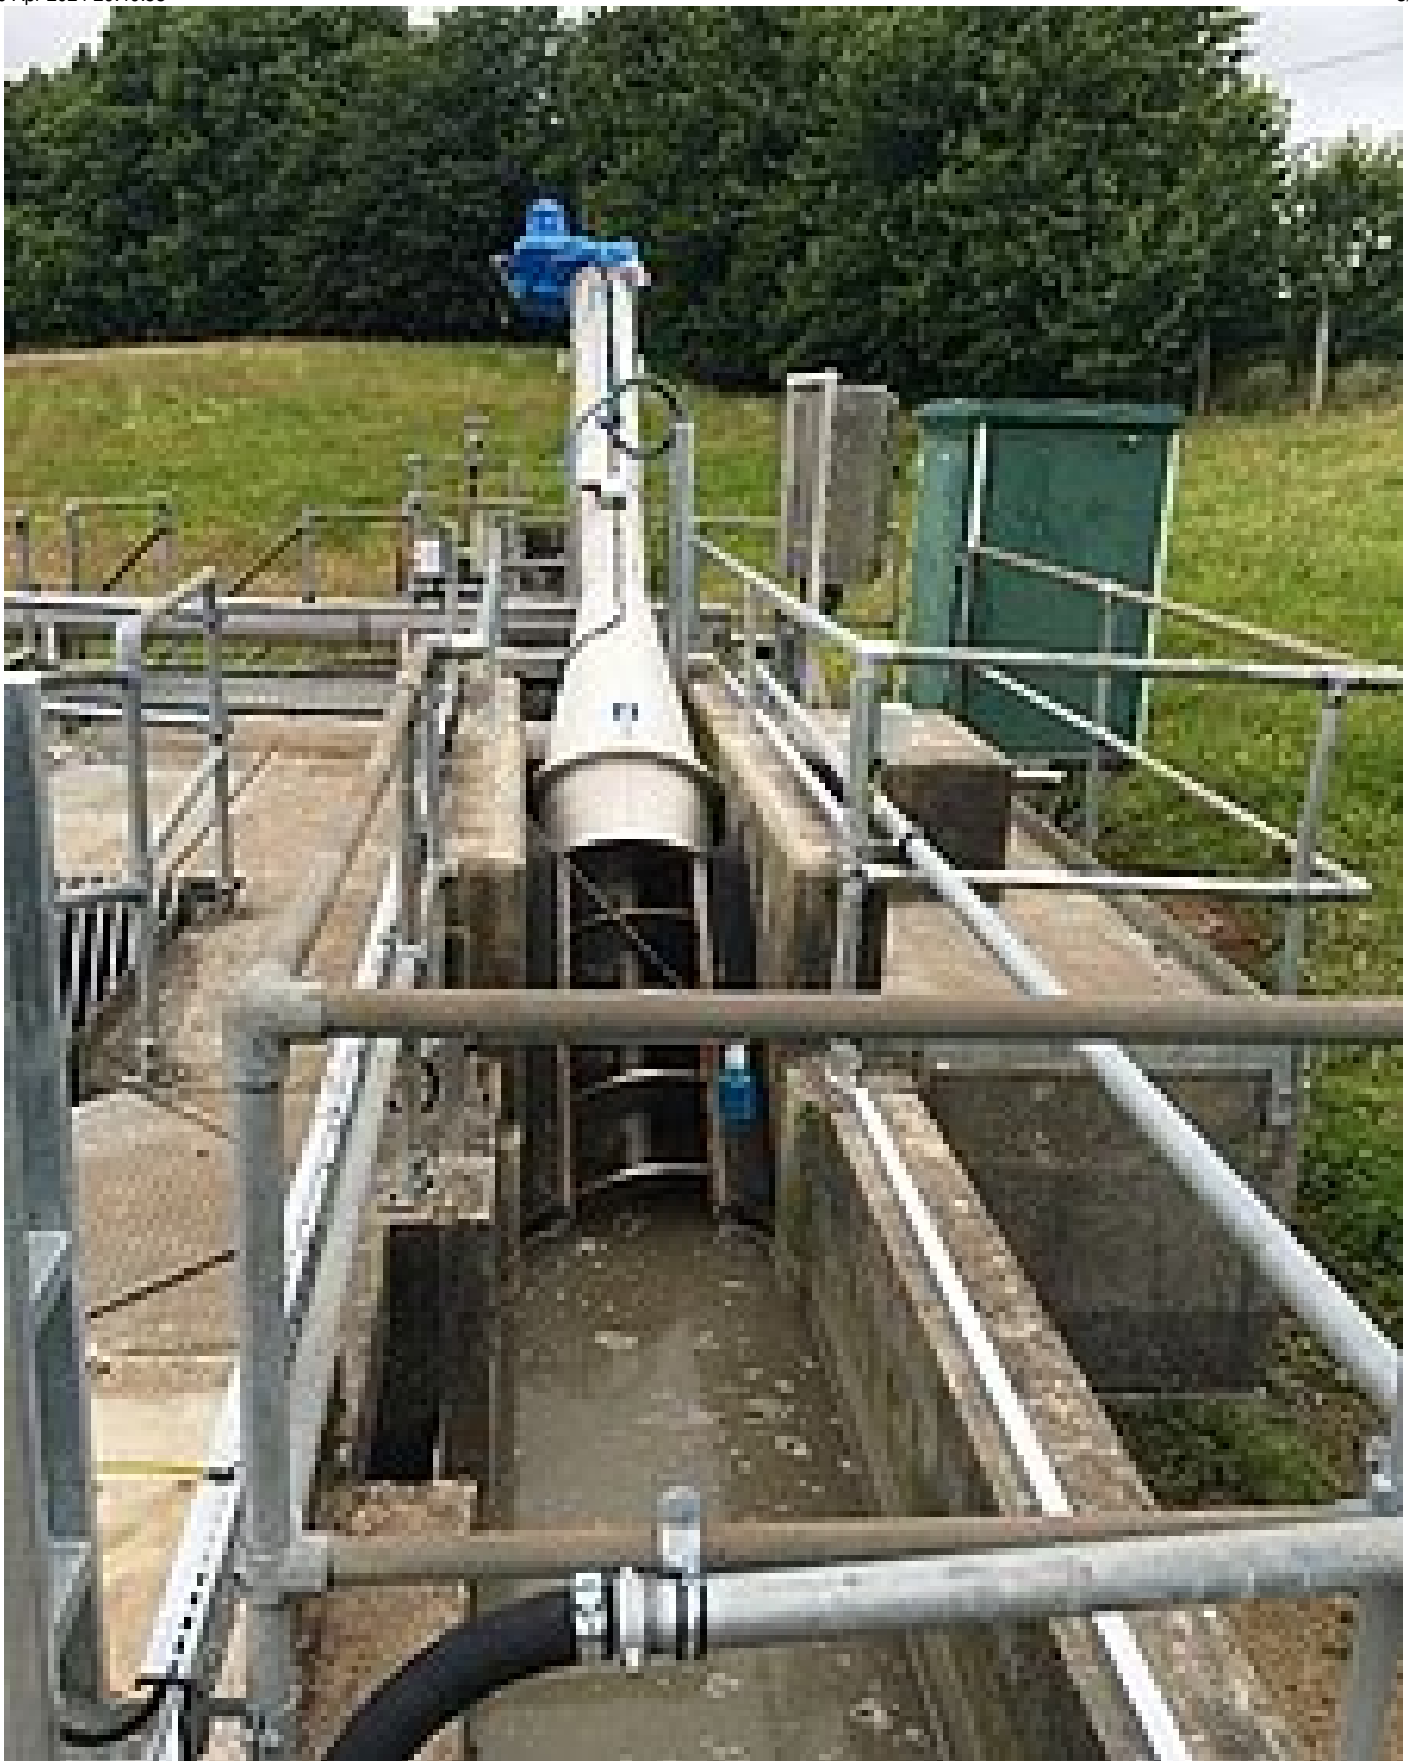
*The modified HUBER Micro Strainer ROTAMAT® Ro9 in the inlet screen channel*

We modified our combined screen (HUBER Micro Strainer ROTAMAT® Ro9) so that it ran without washwater and no compaction, it was essentially a conveyor to elevate the screens into a small washpactor (Washpress WAP®/L). This Inlet screen was one of the first Ro9's without the washwater feature to be supplied into the UK for the Wessex Water inlet screen replacement projects. This innovative idea of discharging from the Ro9 into a launder was a success and is currently working extremely well.

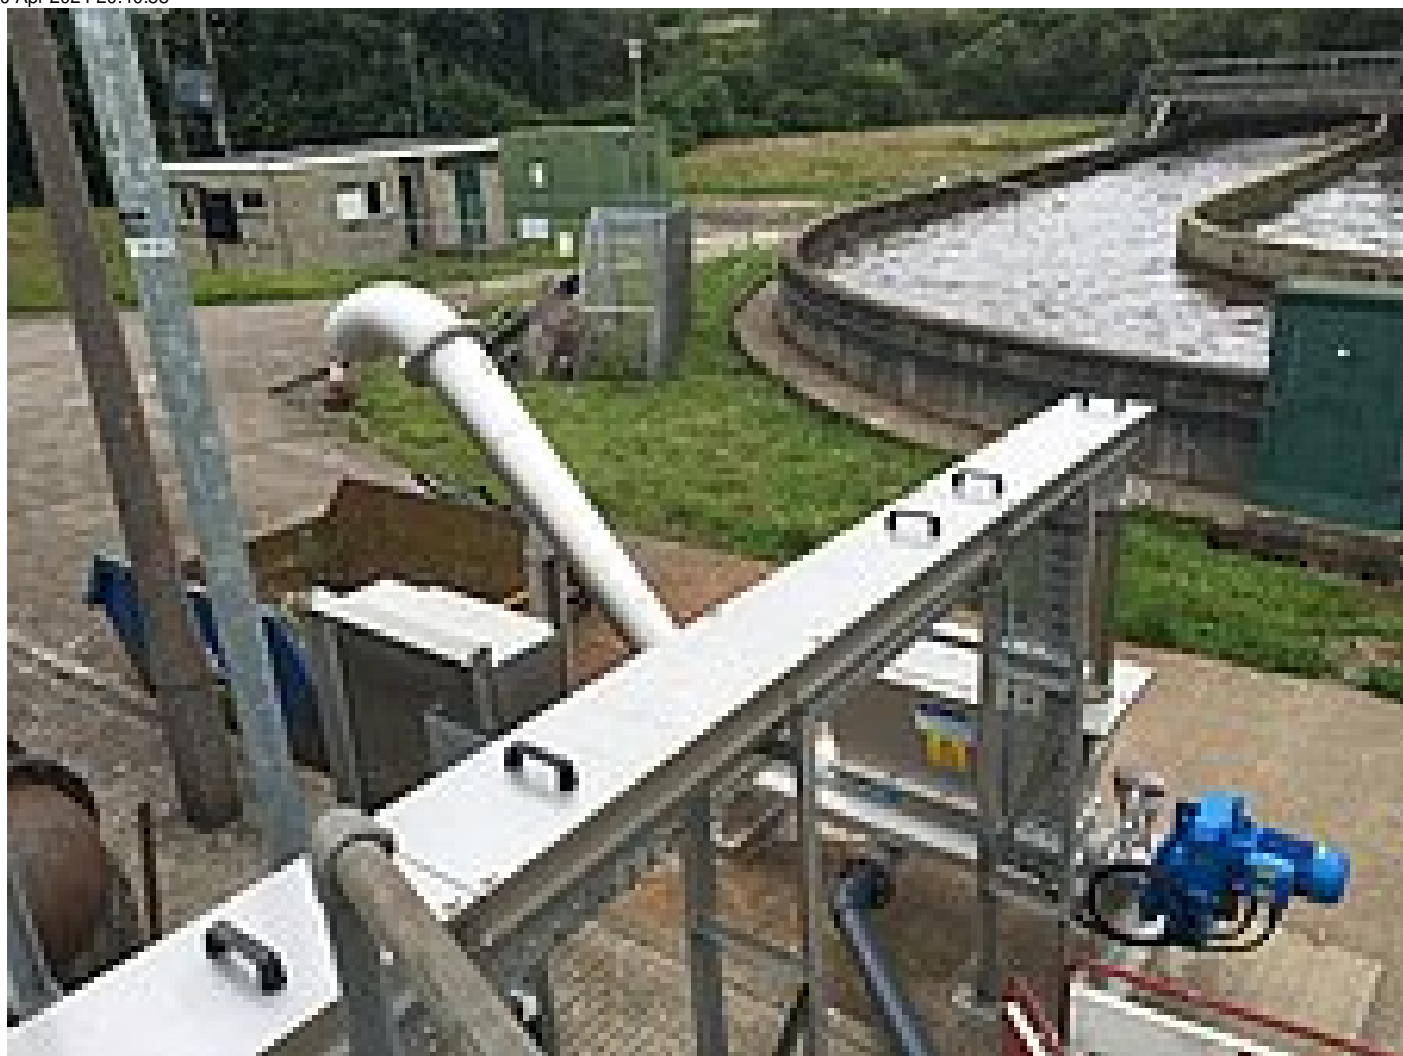
*Launder Channel feeding the Wash Press*

The lack of washwater for the launder resulted in an additional modification - Wessex Water fitting a submersible pump in a chamber upfront of the screen, this chamber had a 6mm perforated plate upfront to prevent large rag blocking the pump. The pump starter was included in our control panel and was linked to the screen start.

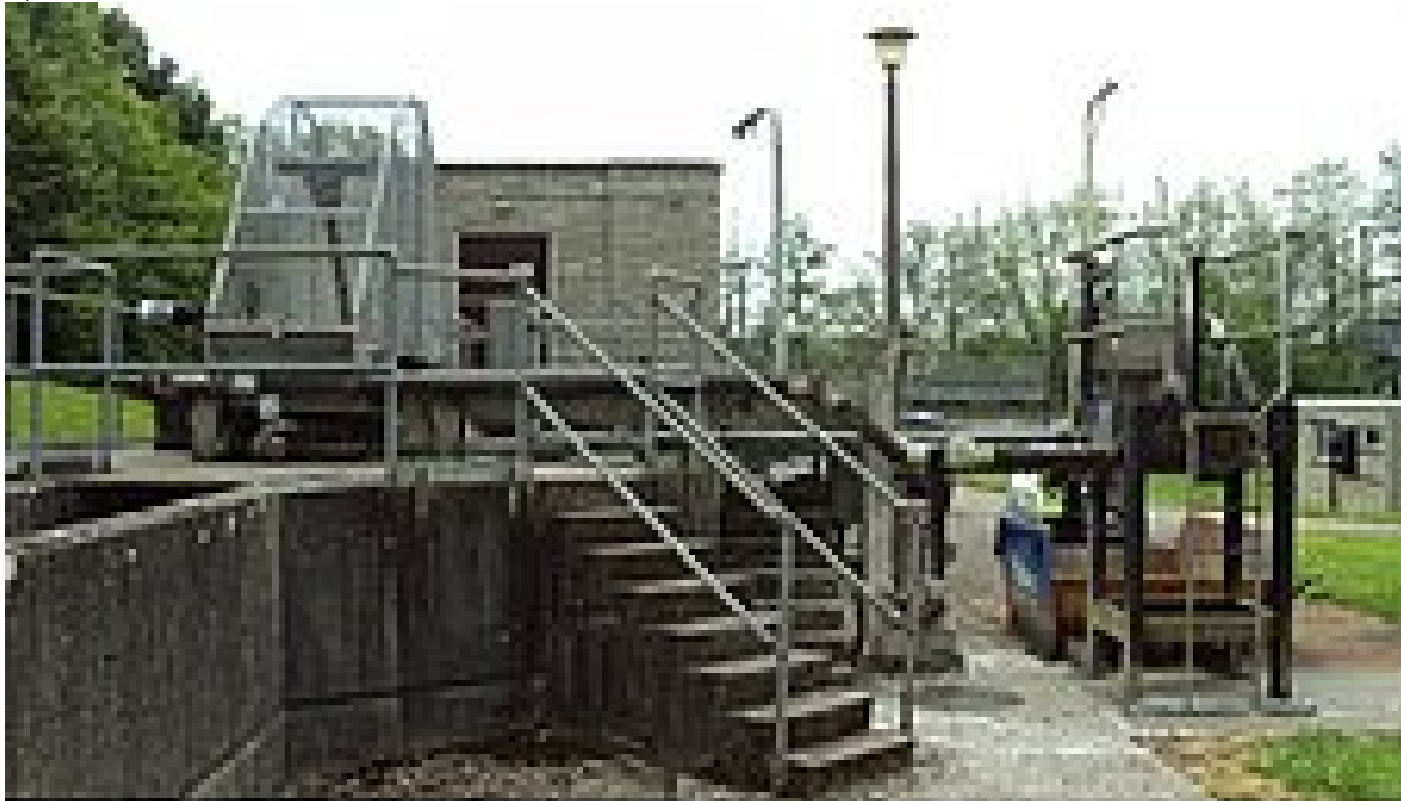
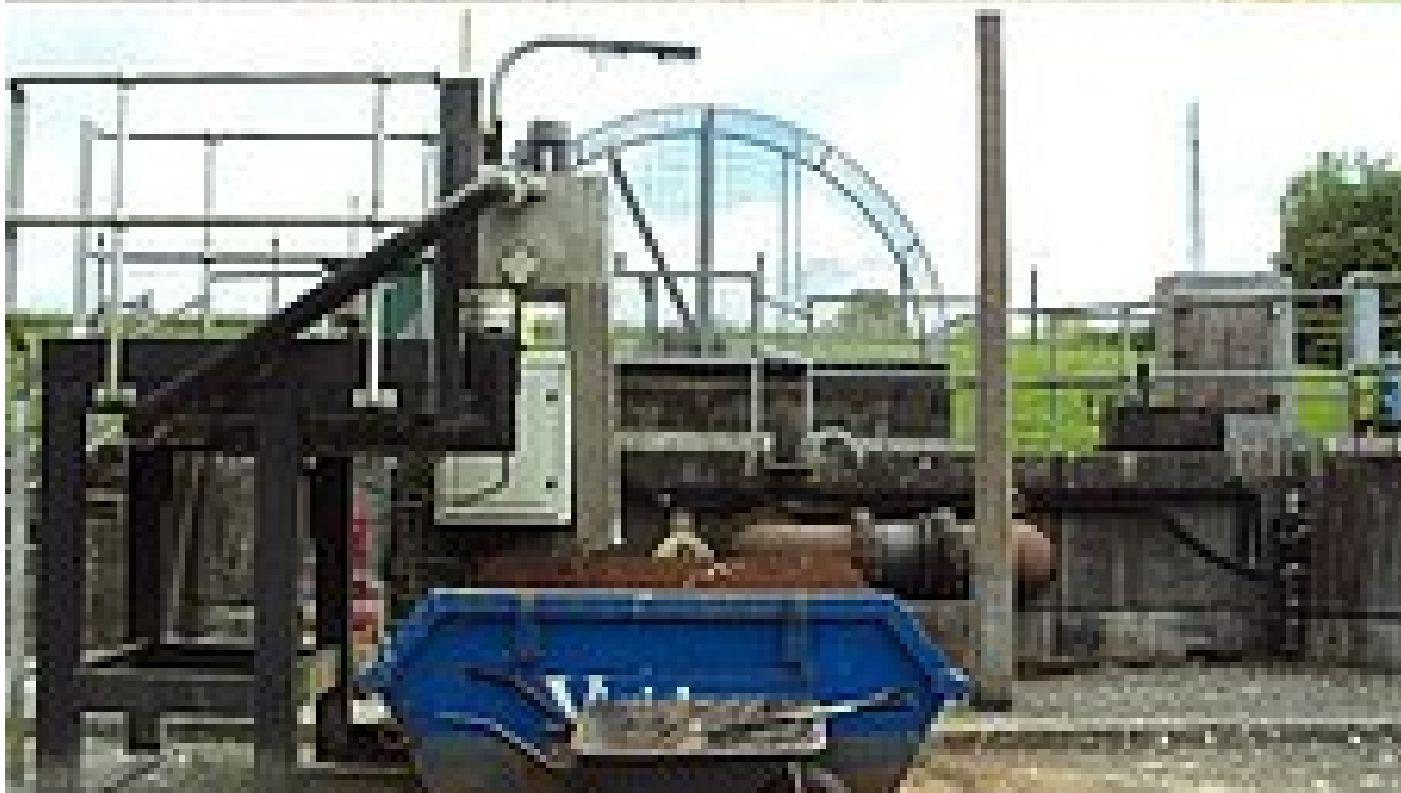
*The old equipment installed was at the end of its asset life and constantly failing*

Installed on site was an old 20mm bar screen discharging into a launder feeding a macerator and licep unit. All the equipment installed were at the end of their asset life and were constantly failing. The inlet screen was also allowing rag to bypass it due to its age.
