## Perforated Band Screens EscaMax® for Anglian Water

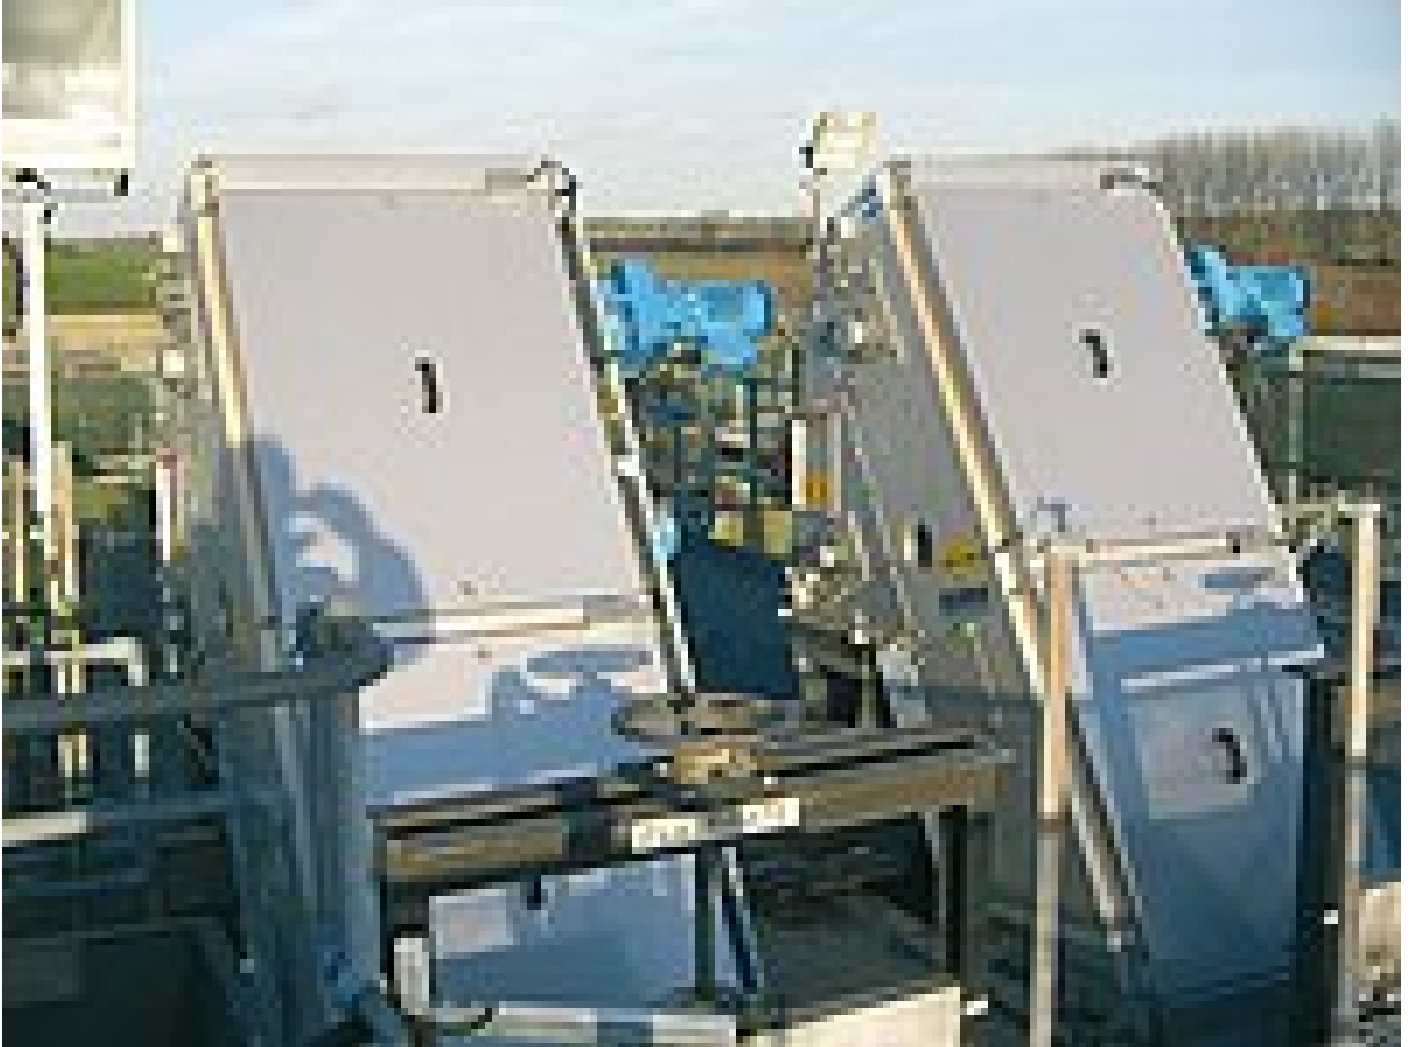
*Sleaford, UK: Perforated band screens EscaMax® 4000*

In co-operation with a local contractor we proposed to remove the existing screen and screenings processing system. We offered a pair of HUBER Belt Screen EscaMax® 4000 perforated band screens with a width of 752 mm and a capacity of 101 l/s, installed at an angle of 60° within the channel, a WAP/SL size 2, and control panels. The local contractor would carry out the removal of the failing equipment, supply of a launder channel and complete mechanical and electrical installation.

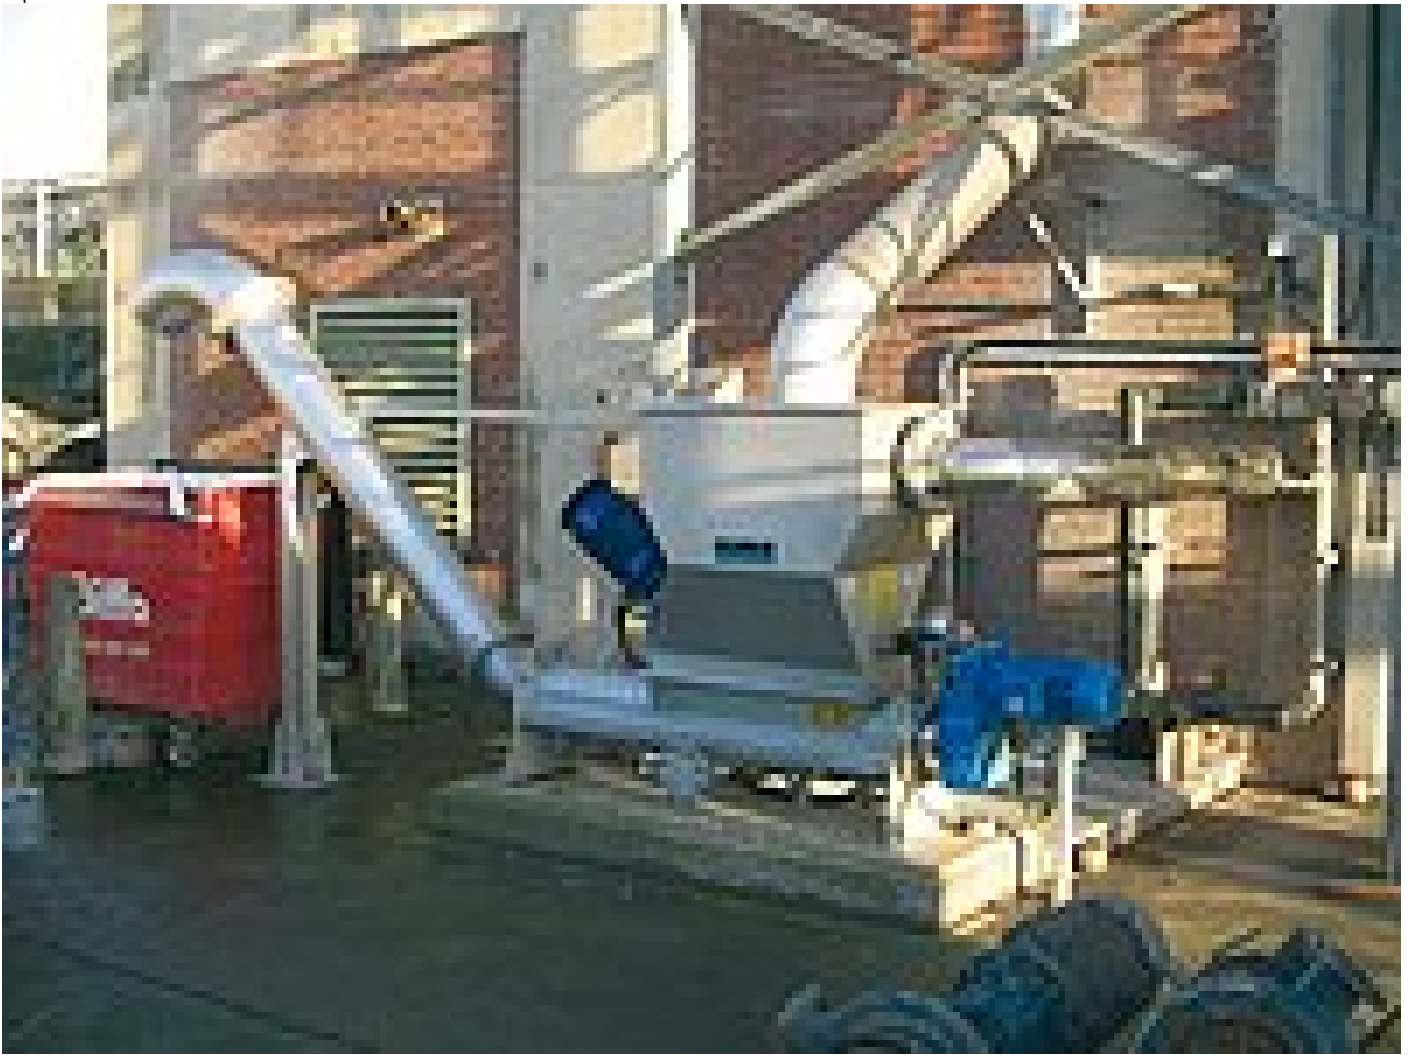
Sleaford, UK: WAP/SL size 4 with launder tube
